Carpet protection tape

Low cost, easy to install floor covering protects aircraft carpets during maintenance activities.

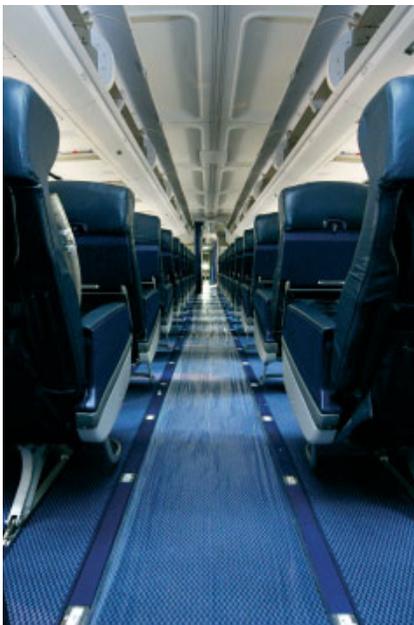
Carpet Protection Tape applied to Boeing 757 under maintenance

Working with 3M, BA identified a new carpet protection system based on 3M 5038A polythene film. The new film has a low tack adhesive that bonds well to the full range of flooring materials used in BA aircraft, including new nylon carpets that had proved difficult to bond to. The film has excellent friction characteristics, making it safe to walk on even when wet and despite its low thickness, it offers better puncture resistance than the previously used disposable film product.

The new film is also supplied in reverse-wound rolls, with the adhesive on the outside for faster deployment and the reduced thickness substantially cuts the volume of waste material generated during maintenance activities.

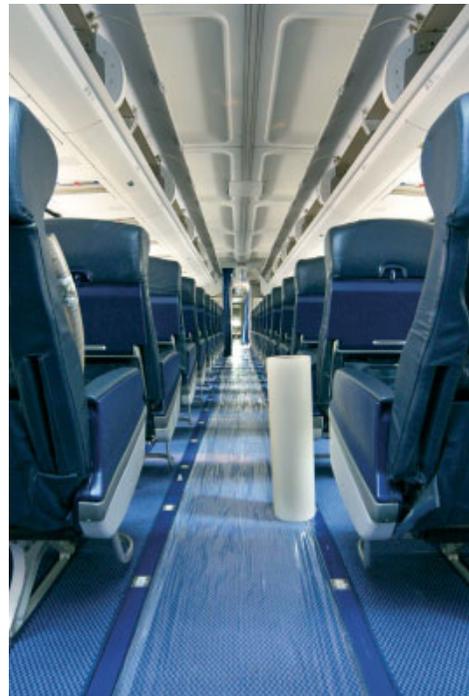
Carpet Protection Tape - typical usage
