Structural Performance Tests of VHB™ Tapes in Architectural Metal Panels

Technical Bulletin

May, 2007

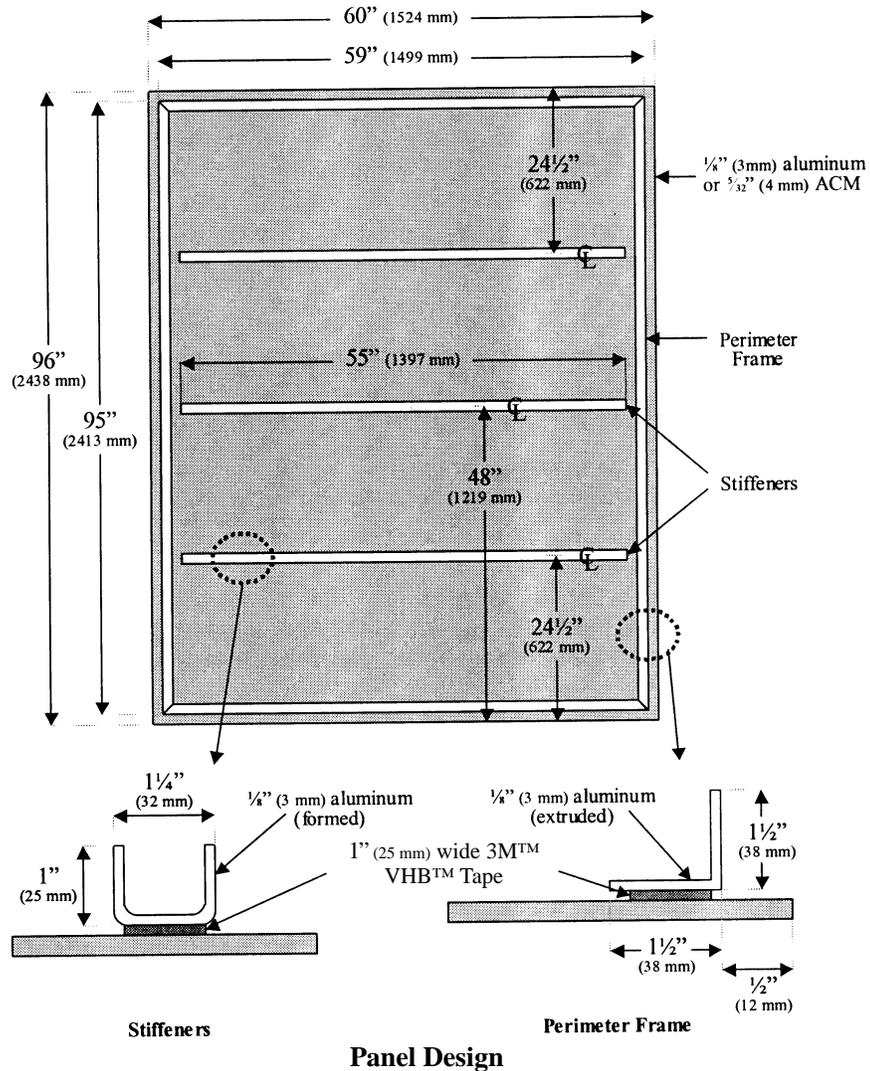
The panels submitted for the construction tests were built at a leading manufacturer of architectural metal wall panel systems using designs, assembly procedures, and factory conditions typical of the construction industry. The panels measured 5' x 8' (1524 mm x 2438 mm) and were made of either aluminum sheet or aluminum composite material (ACM). An extruded aluminum perimeter frame and three aluminum stiffeners were attached to the backside of each panel using only 3M™ VHB™ Tape. No mechanical fasteners, liquid adhesives, or any other bonding material were used in the assembly of these architectural panels.

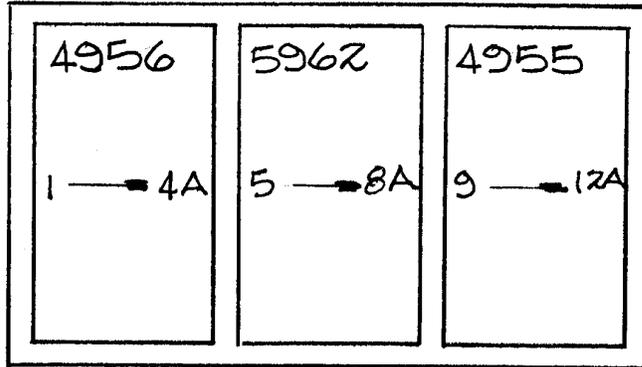
TEST
SEQUENCE
NO. 1

| Test Sequence 1 | This test sequence consisted of measuring the air leakage, water penetration, and wind load structural performance of a set of architectural panels built with 3M™ VHB™ Tapes that had experienced thermal cycling. |
